Timber Measurement Society Meeting Log Roll-out, Boise Building Log Yard
White City, Oregon, October 19, 2007

Note: the following log descriptions are based on one person's east-side numbers and may not match the "school book" answers which were developed (we will report the school solutions when I can obtain them).

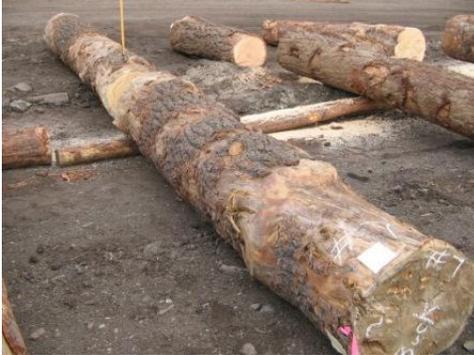
Top

I did not take notes, but I culled the top (conk and twist) and took a 4' length cut (for conk) and a 3" diameter cut (twist) out of the butt. From the looks of pictures, I hit it about right.

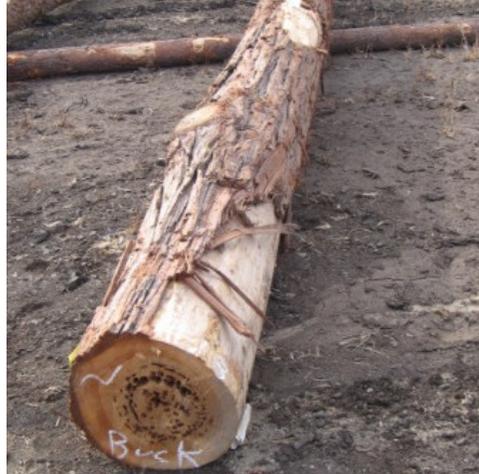
Top

I used the USFS standard rule for Incense cedar and squared a 11" x 12" x 16 area (pecky rot) and a 1' length cut (crook, sucker) out of the top (pecky rot) which culled the top.; out of the butt I squared a 4" x 5" x 16'. This log is obviously much worse than what I thought (I applied the rule as I understood it), however, I have never scaled incense cedar before this (so what do I know).

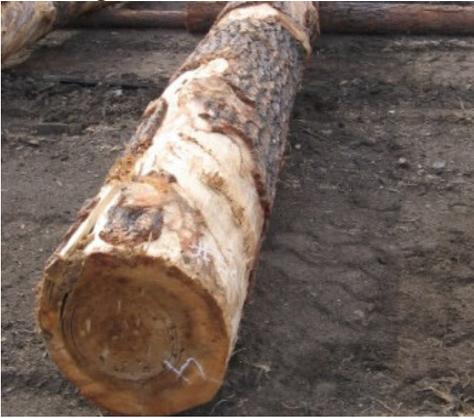
Top

I culled this whole log. I cannot remember if it had paint knots, but certainly the rot in the top, the frost crack, shake and breakouts don't look good. Again, judging from the picture, I was in the ballpark on this one.

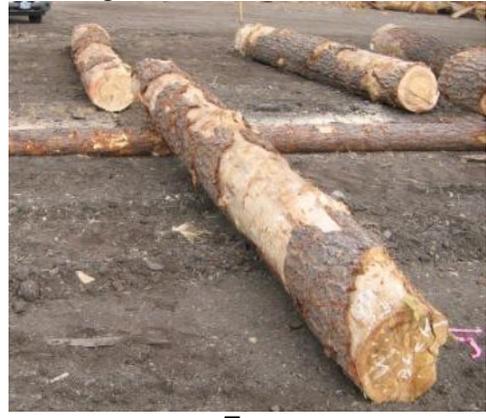
Top

I took a 10' length cut out of the top and culled the butt. This log has some serious shake and frost cracks (I don't recollect if it had Indian paint as well). I don't see anything to make me change my call, so I guess the verdict is still out on this one (just can't tell enough from the picture).

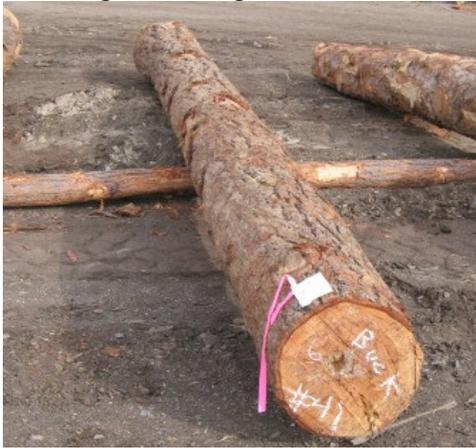
Top

I squared a 5" x 10" x 12' in the top; and a 6" x 11" x 13', plus a 1' length cut in the butt. Judging from the pictures the rot and seams did not connect (I would say that I hit this log too hard).

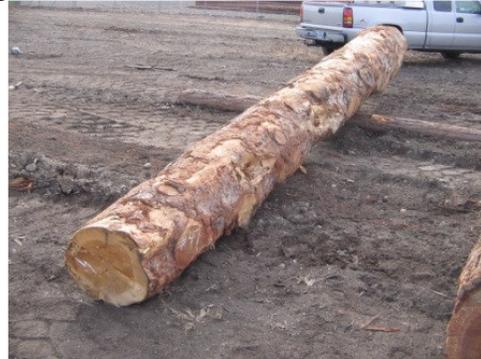
Top

I took a 3" length cut in the top plus a 1" diameter cut for oversize rotten knots; and took a 2 length cut out of the butt. The pictures seem to show some rot where the log was bucked, but not too much. Based on what I can see in the photos, I don't see anything to indicate that this log was any worse (apparently somebody felt the rotten knots were worse?).
